Emergency Repairs to Garden State Parkway Culvert

Township of Cranford | Union County, NJ

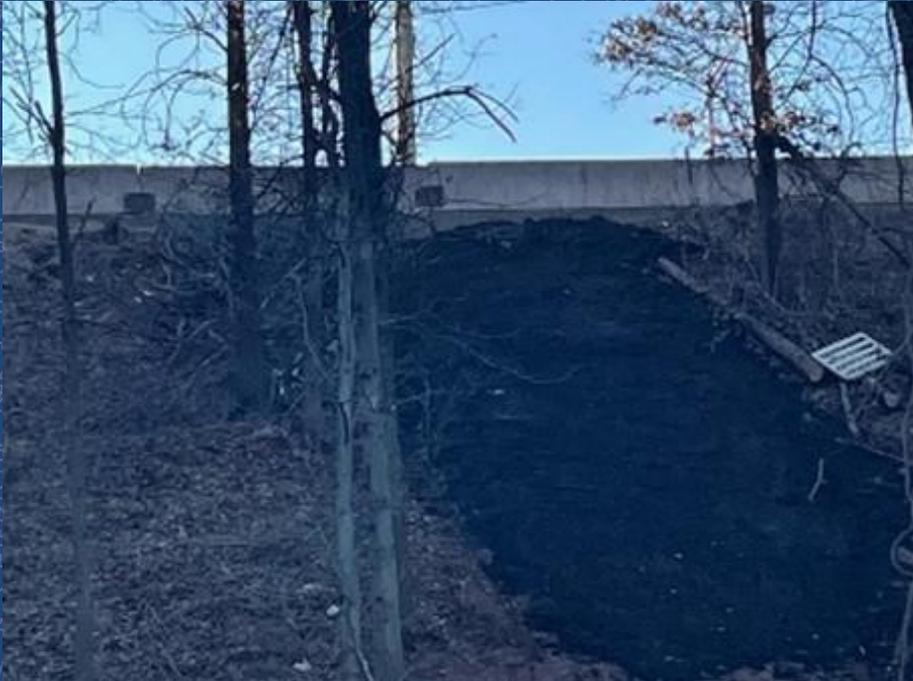
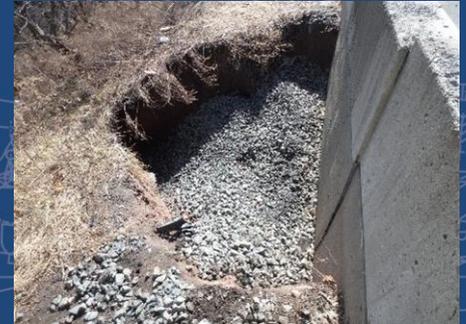
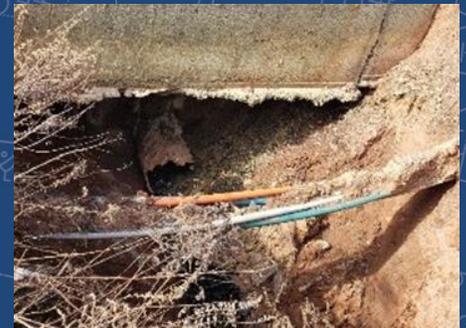
Van Cleef was contacted to review an emergency condition discovered by NJTA Maintenance near MP 138.4 along the Garden State Parkway right shoulder. A sinkhole formed in the right shoulder embankment and the adjacent roadway barrier had rotated and settled. Van Cleef was immediately requested to provide a field inspection and develop repairs.

The cause of the erosion was determined to be a broken 15" CMP pipe and a deteriorated inlet. Repairs were also made to the settled barrier to stabilize the settlement and other maintenance repairs were specified such as flowable backfill, replacement of the entire CMP pipe to the outfall, and new casting/grate and concrete collar for the inlet. The existing fiber optic cables, exposed by the heavy erosion, were to remain in place.

Repair plans were developed for implementation by NJTA Maintenance and an on-call Contractor (Mount Construction) within 24 hours of the field visit.
