Emergency Repairs to GSP Bridge #75.3, Lacey Road

Township of Lacey | Ocean County, NJ

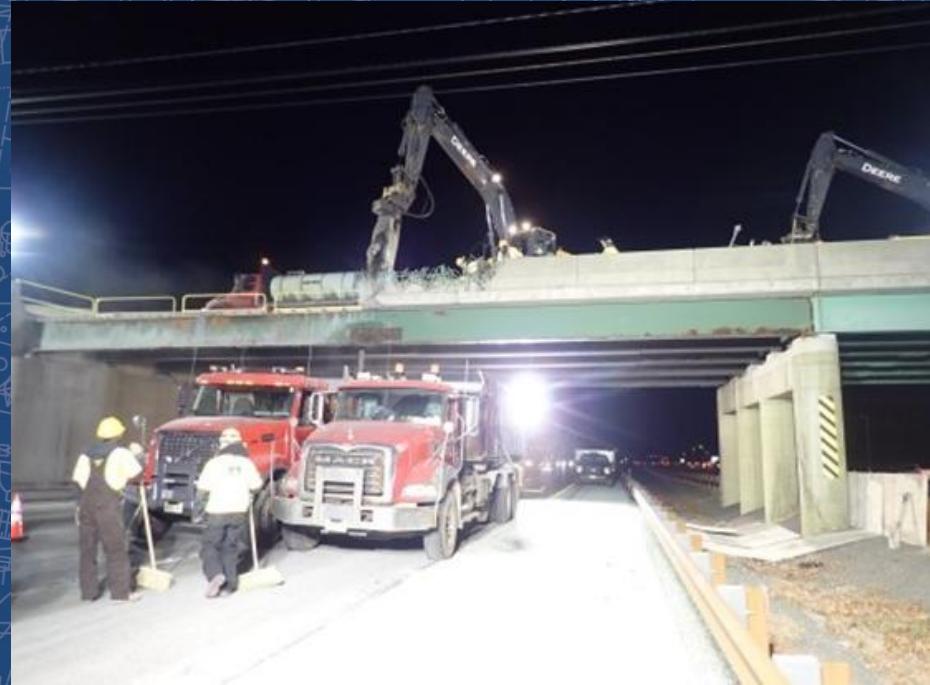
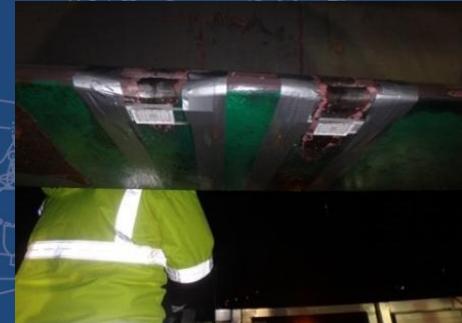
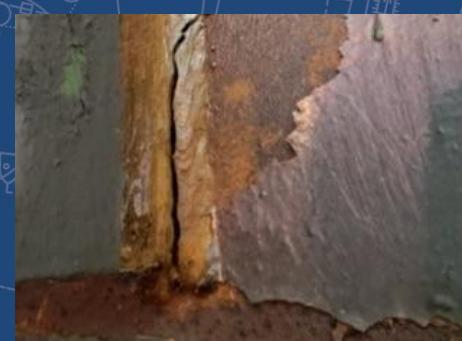
Van Cleef was requested by the New Jersey Turnpike Authority (NJTA) to perform a hands-on inspection of the steel superstructure at Structure No. 75.3 (Lacey Road over Parkway N/S in Lacey Township) due to numerous over height vehicular impacts to the girders in both spans over the past several years. During our inspections in early November 2018, several locations of impact damage not previously noted were discovered, as well as more significant damage (cracks) in the north fascia girder bottom flange cover plate in Span 2.

During the process of recommending interim and priority repairs, the bridge was again struck by an over height truck carrying a backhoe along Parkway N (GSP NB) on December 19, 2018, and the Van Cleef inspection crews responded immediately and remained onsite into the early morning hours. Another hands-on inspection found the new impact caused additional and irreparable damage (i.e. additional cracks in the web, and prior cracks in cover plates which had propagated) to the north fascia girder. This resulted in on-site emergency repairs directed by Van Cleef inspectors (drilled arrest holes and interior diaphragm replacement) and the emergency closure of the Lacey Road westbound lane on the bridge to all traffic.

Van Cleef was asked to provide emergency engineering services to assist the NJTA in the assessment of damage, installation of temporary repairs, specialized inspections, maintenance and protection of traffic (MPT), and the development of final design documents to replace the girder and restore the load carrying capacity of the bridge. Van Cleef coordinated directly with the NJTA Construction, Engineering and NJTA's on-call emergency Contractor, George Harms Construction, to implement a "design-build" construction scheme, including the immediate installation of a long-term traffic shift on Lacey Road.

In addition to the structural and MPT design and plan preparation, work also included performing weekly nighttime monitoring inspections of the damaged girder to ensure that cracks were not propagating further, developing temporary supplemental steel repairs using Contractor's stock yard steel, monitoring the girder during nighttime demolition and removal operations, providing construction support services, and extensive coordination with Ocean County and Lacey Township to assist in traffic relief options.
